## Water Compliance Inspection Report

***NPDES STORMWATER  
Inspection Report***

***AURORA ENERGY SERVICES, LLC  
SEWARD COAL TERMINAL  
SEWARD, ALASKA***

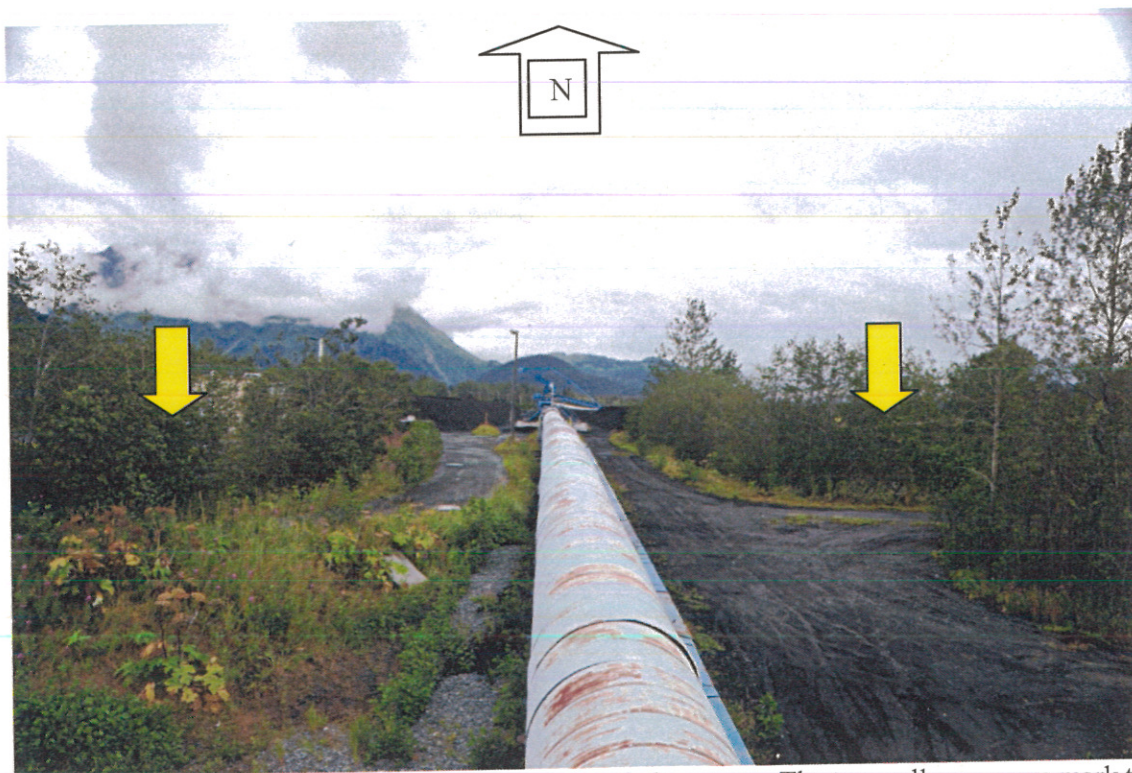
**Photo 3:** Looking North along the covered coal conveyer belt system. The two yellow arrows mark the location of the stormwater retention ponds on the Seward Coal Terminal.

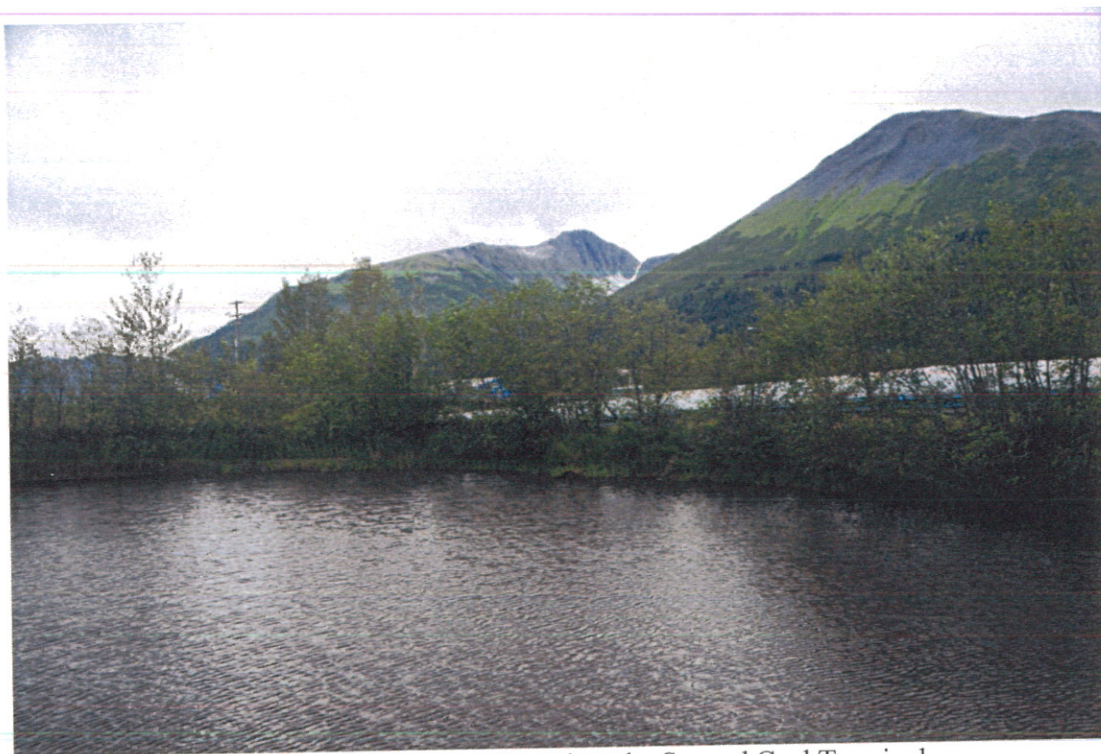
**Photo 4:** Looking at the east stormwater retention pond on the Seward Coal Terminal.

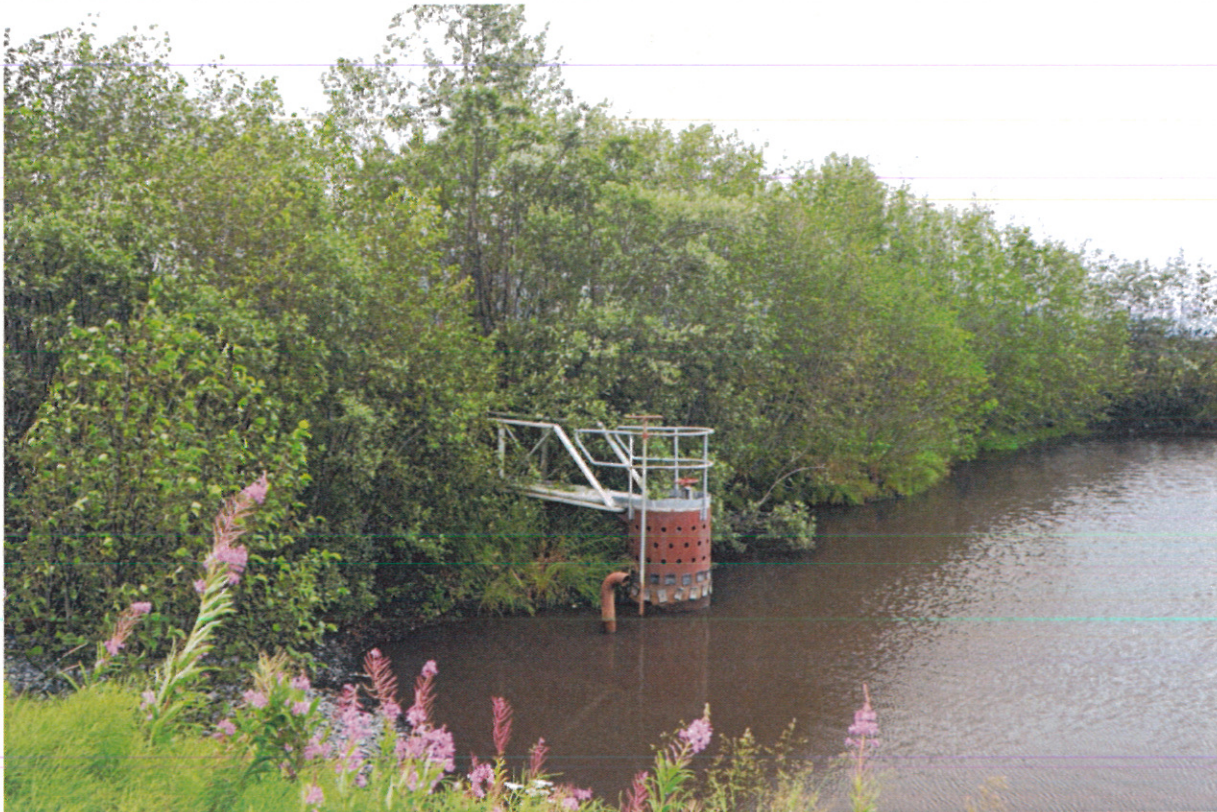
**Photo 5:** Sampling station on the east stormwater retention pond where the operator Aurora Energy Services collects the monitoring data for the SWPPP.

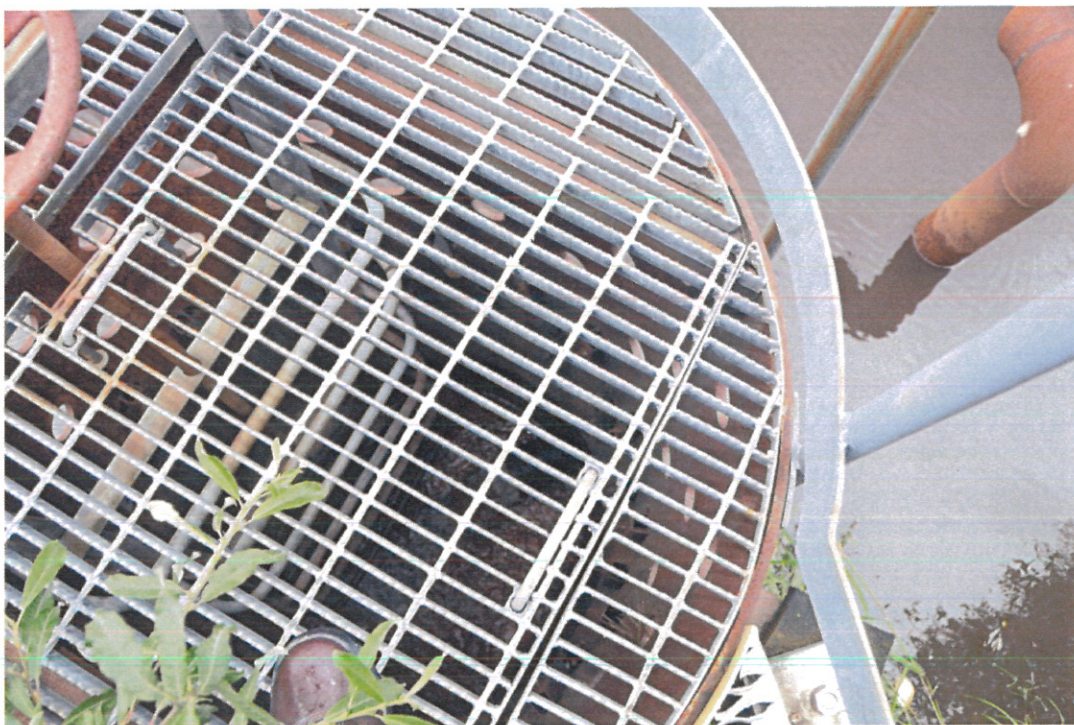
**Photo 6:** Sampling station on the east stormwater retention pond where the operator Aurora Energy Services collects the monitoring data for the SWPPP.

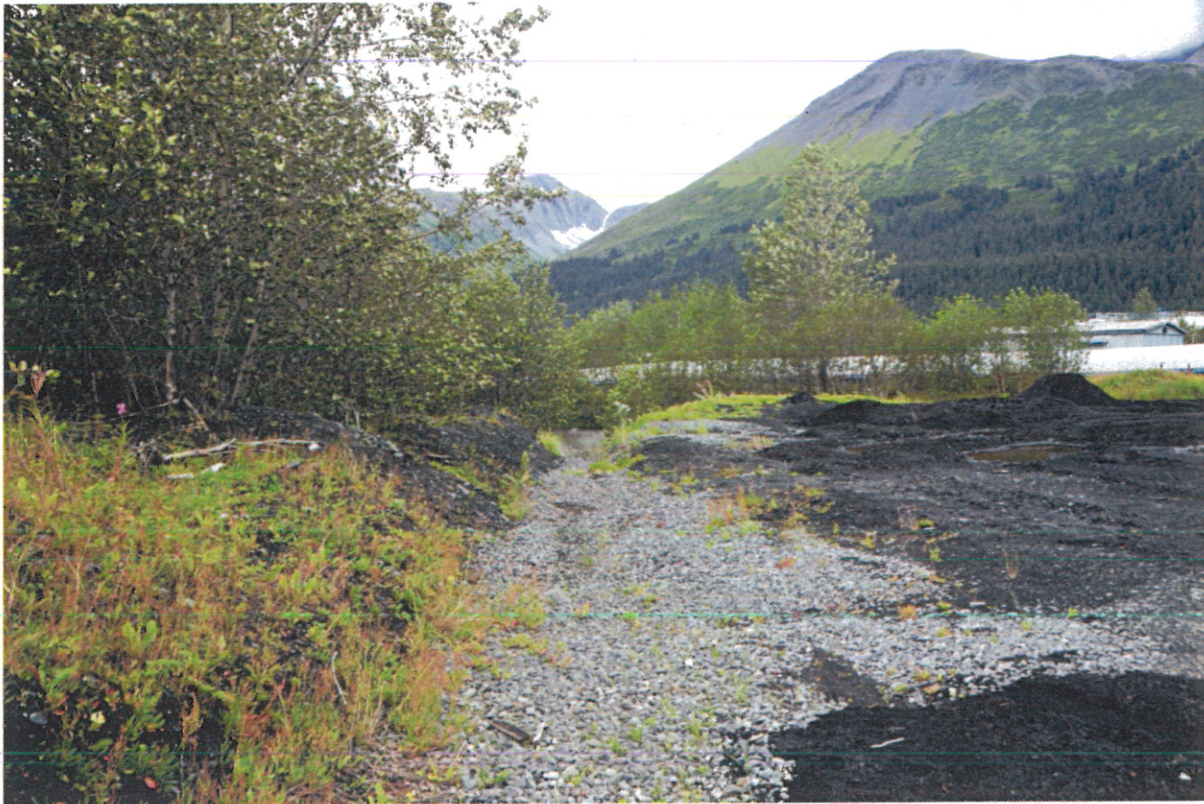
**Photo 7:** Looking West towards the east retention pond with gravel area sloped to towards the pond to direct any stormwater runoff into the settling pond along the eastern portion of the facility.

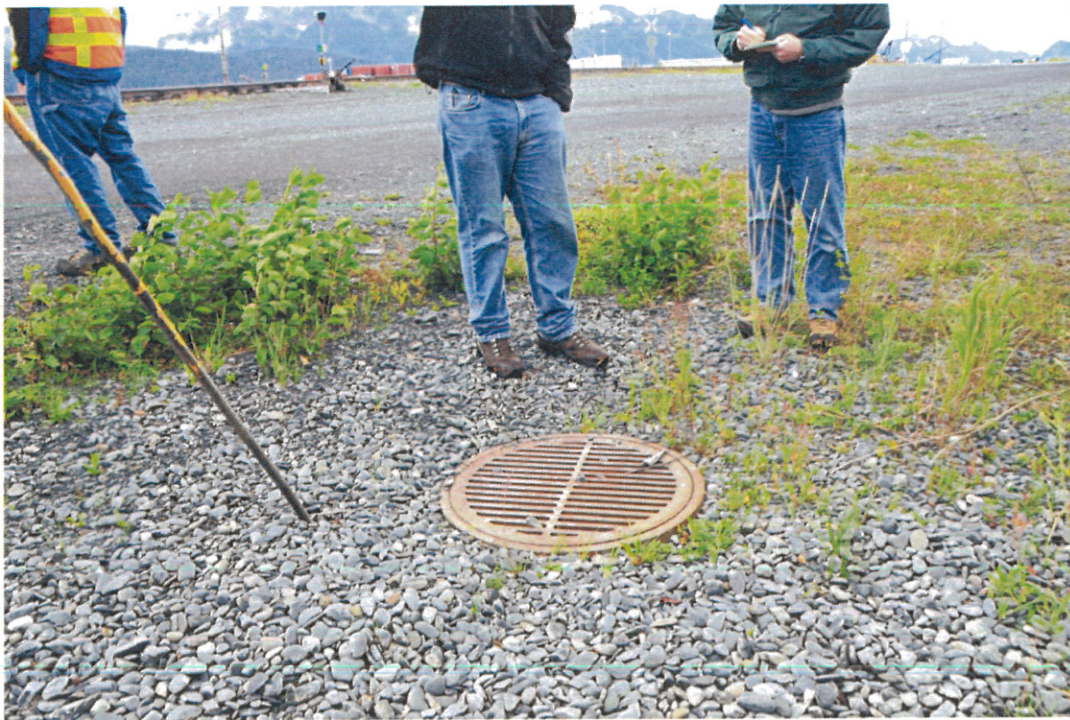
**Photo 8:** This photo shows a catch basin used to help collect stormwater runoff along the eastern edge of the facility. The road behind the personnel standing in the photo slopes towards the catch basin.

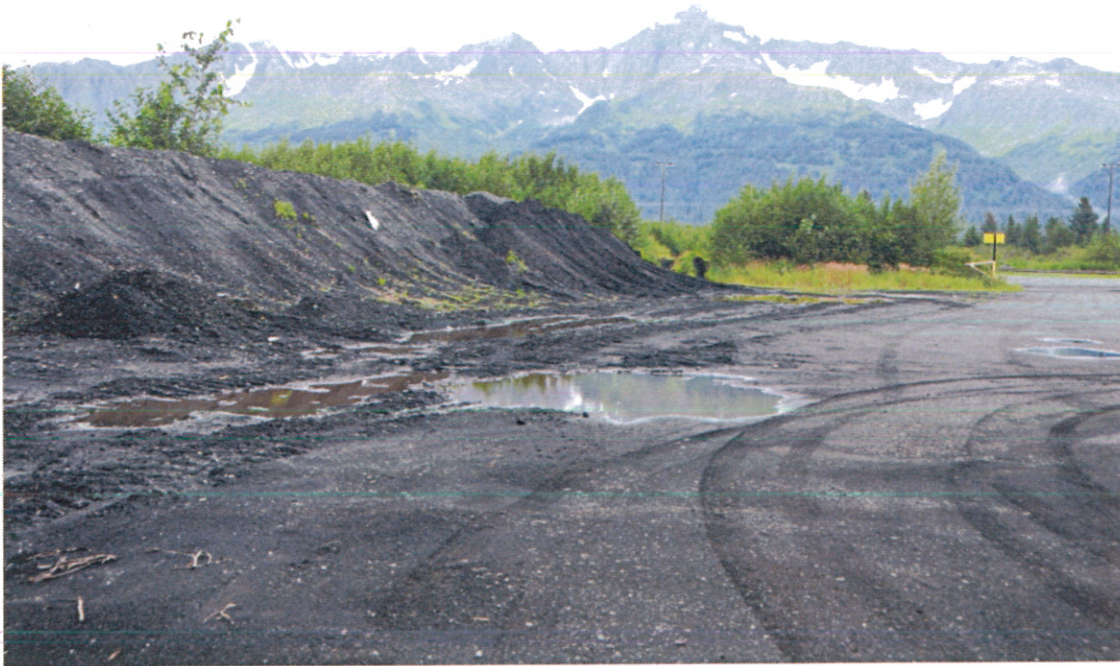
**Photo 9:** At the northern end of the property the operators have a large berm keeping the stormwater runoff contained on the facility. The berm is seen on the left side of the photo.

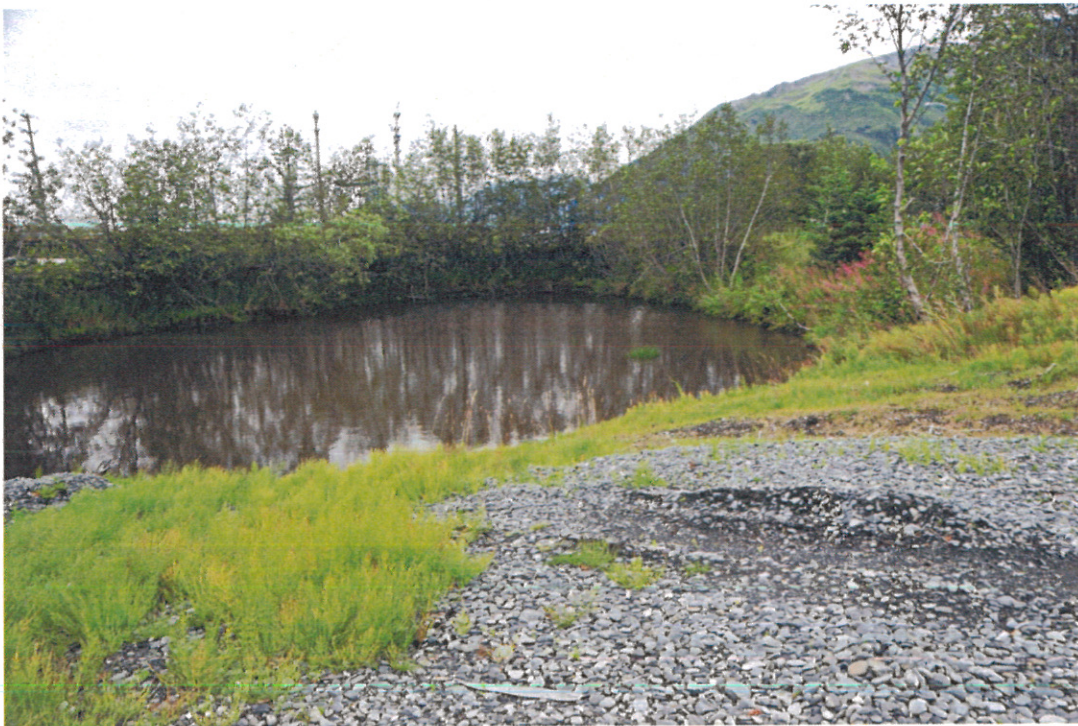
**Photo 10:** Looking South at the west stormwater retention pond which is connected to the east retention pond by a flow through pipe.

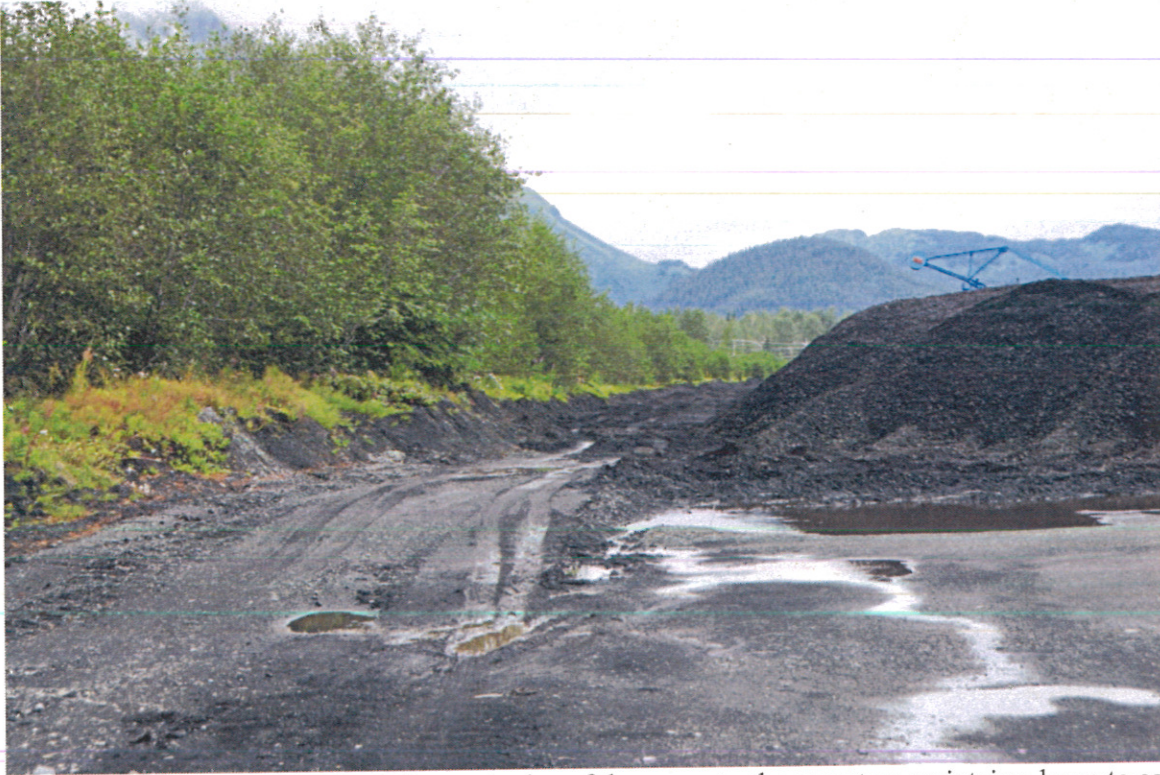
**Photo 11:** Looking Northerly along the west edge of the property the operators maintain a berm to contain any stormwater runoff from leaving the facility. The berm can be seen on the left side of the photo.

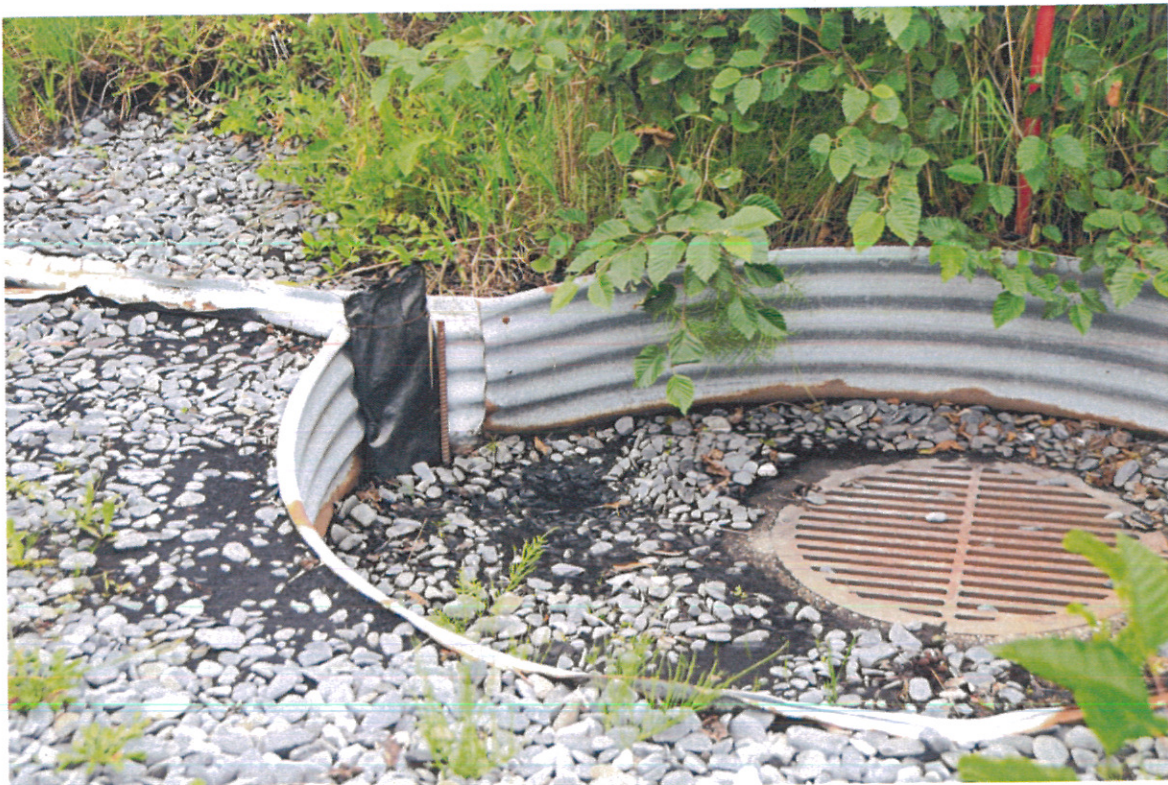
**Photo 12:** Photo shows another catch basin connected to the retention ponds.

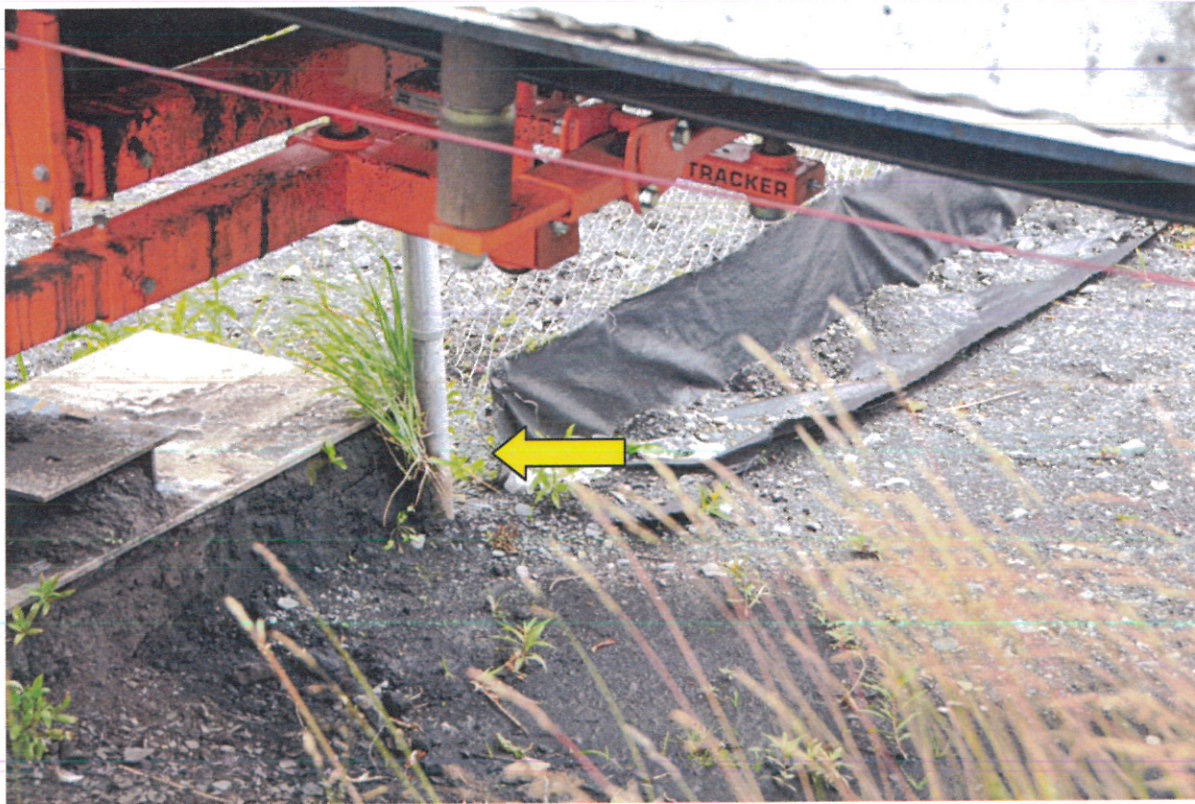
During the site review and tour, I noticed a small opening in the silt fence under the dock that the conveyor belt system runs along used to carry coal out to the ships. Stormwater passing through this opening would ultimately enter Resurrection Bay. The bay was approximately 25 feet from the fence line at the time of the inspection. This was noted to the facility staff while walking the site. Other than the silt fence small hole, I did not see any other areas of concern during this inspection.

**Photo 13:** At the south end of the terminal near the shoreline a small section of silt fence was torn away. This opening appears to be animal excess area to the beach. A yellow arrow marks the hole in the fence.

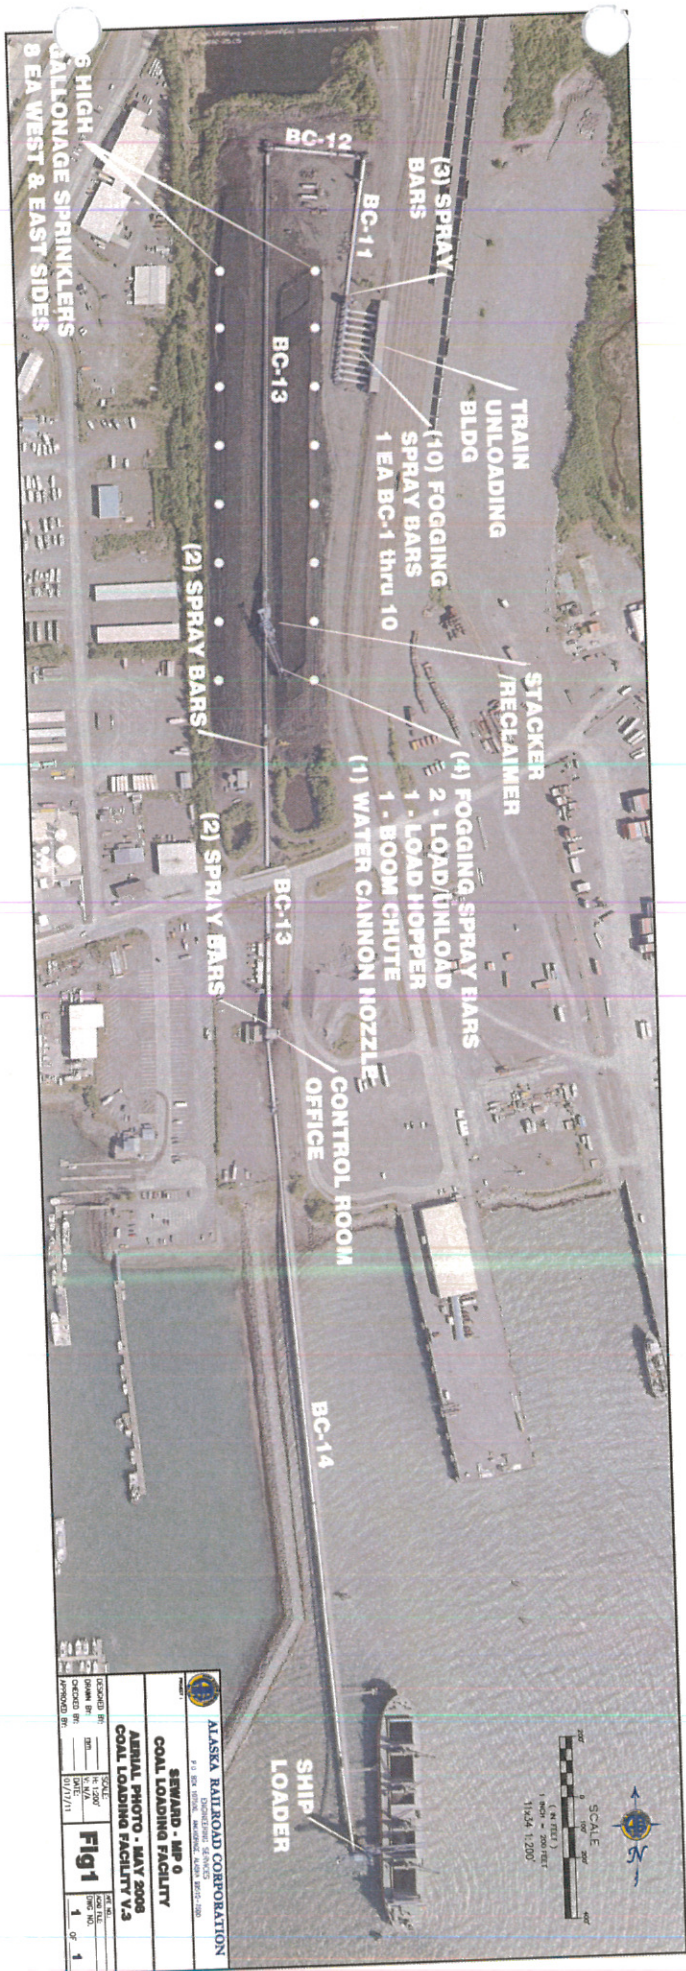
We then asked Mr. Brown, to give us an overview of the facility, pointing to a labeled aerial photo of the Seward Coal Facility, which is included in Attachment B. He said that they use water spray bars, sprinklers and fog sprayers at various points in the coal unloading building, storage piles and conveyor lines to prevent dust. These locations were clearly marked on the aerial photo. He also pointed out that much of the conveyor line system is partially or fully enclosed.

<b>ALASKA RAILROAD CORPORATION</b> <small>1000 EAST 10TH AVENUE, ANCHORAGE, ALASKA 99501-3000</small>			
<b>SEWARD - NP 0</b> <b>COAL LOADING FACILITY</b> <b>AERIAL PHOTO - MAY 2008</b> <b>COAL LOADING FACILITY V.3</b>			
DESIGNED BY	DATE	SCALE	FIG 1
CHECKED BY	DATE	SCALE	1
APPROVED BY	DATE	SCALE	1
